East Coast Rivers Cruising Companion

20th Edition

Update No. 4 – April 2021

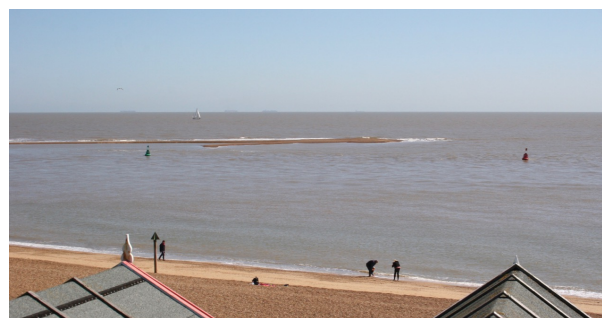
The three Knoll entrance buoys are very close to the beach this year. The Knoll Spit (port-hand) buoy and the Mid Knoll (starboard-hand buoy) can be seen in this photo, taken on April 23rd from the Cliff car park at Felixstowe.
